# CLIENT MONTHLY ENVIRONMENTAL REPORT

**SICTL Container International Container  
Terminal Limited**

**Report Number:** 03

**Period:** September 2014

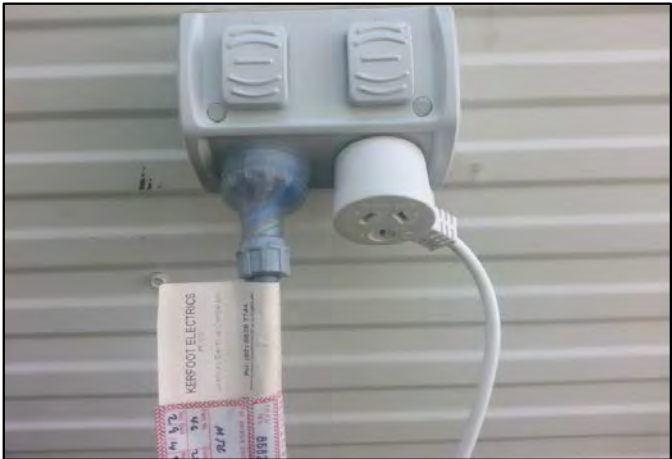
No.	Details	Score	Comment
1	Risk of electrocution due to IP53 plug (vending machine) used outside in uncovered area.	-1	Rectified by Project Manager 10/09/2014.
2			
3			
4			
5			
Total		-1

Photo 001: IP53 plug (right) used to power vending machine plugged into an outside outlet which is exposed to rain.

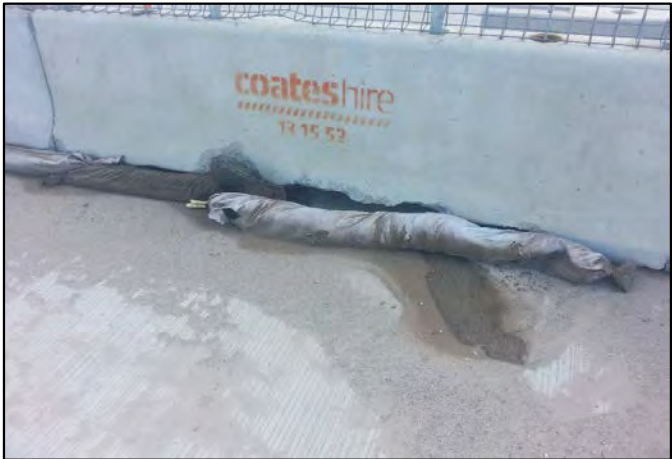
13	Vehicle management plan in place and reflected on site (P)	Y	2	
14	Erosion and sediment controls installed, intact and reflected on current ESCP (P)	P	1	Silt socks along the port road boundary and the bay boundary need housekeeping.
15	Hazardous substances stored in cabinet / ventilated and bunded container, SDS, spill kit available (P)	Y	2	
16	Watercart used to suppress dust	Y	1	
17	Site entry point is clean and free of loose materials	Y	1	
18	Loads are covered on entry and exit from site	Y	1	
19	Monthly testing and tagging of electrical equipment up to date	Y	1	
20	Worksite tidy and maintained (material storage, rubbish, trip hazards)	Y	1	
21	Container organised and tidy	Y	1	
22	Amenities clean and tidy	Y	1	
23	Waste Register up-to-date and dockets available.	Y	1	
24	Weekly consultation toolbox talk conducted.	Y	2	Performed 10/09/2014
		<b>Total</b>	<b>34</b>

Photo 002: Example of silt sock in need of attention and build up of sediment.

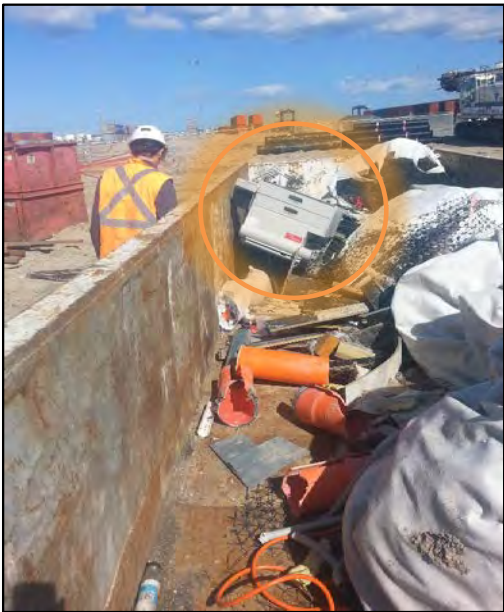
Photo 003: Printer in general waste bin.

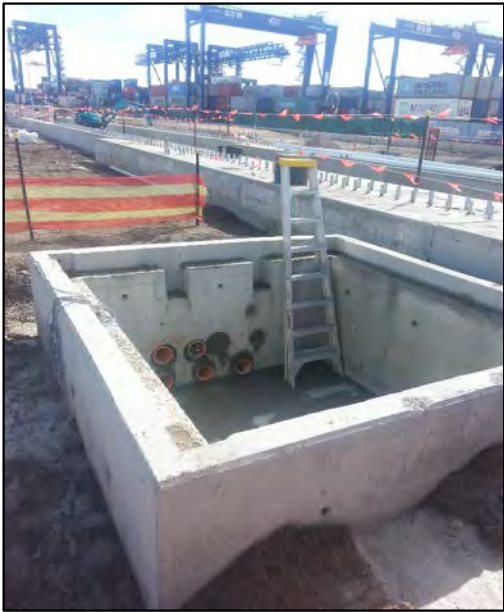
Ref	Hazard (description, location, contractor, instruction, recommendation)	Due Date	Record of Close Out (initial / date)
9	Workers on poorly secured ladders and un-anchored ladders being used to access pits.	10/09/2014	Rectified by QSE Coordinator and Project Manager 10/09/2014.
14	Silt socks along the port road boundary and the bay boundary need housekeeping. Recommend workers replace worn out socks, realign poorly placed socks and remove built up sediment.	17/09/2014	
NOTE	The following additional observations were made during EPRM audit: Printer thrown into general waste bin (contains heavy metals), Pedestrian access to Boral batch plant is poor, unable to locate truck wheel wash sign, sediment basin beginning to degrade, chemicals stored outside of secondary spill containment bins (black plastic containers).		
NOTE	Fire extinguishers not correctly stamped outside client office, site office and site container. Fire extinguisher outside change room did not have a servicing tag. Recommend contacting service provider to remedy the issue. Burton Resource Department can assist with servicing.

Photo 004: Example of one of the unsafe ladders in use. This example shows the primary access and egress ladder to this pit is not anchored in anyway.

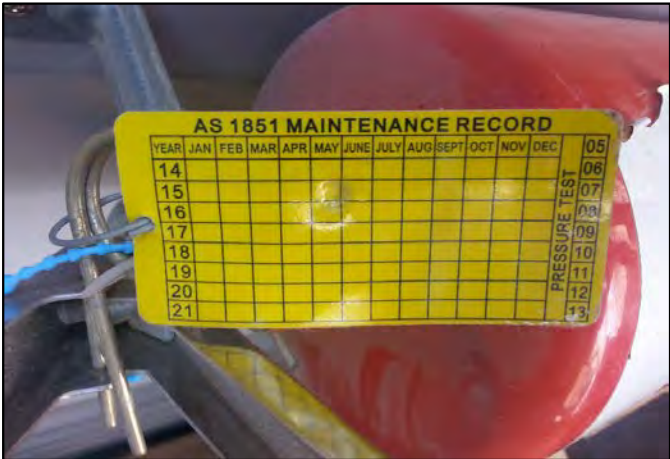
Photo 005: Example of one of the incorrectly stamped maintenance record. This record shows it was performed in

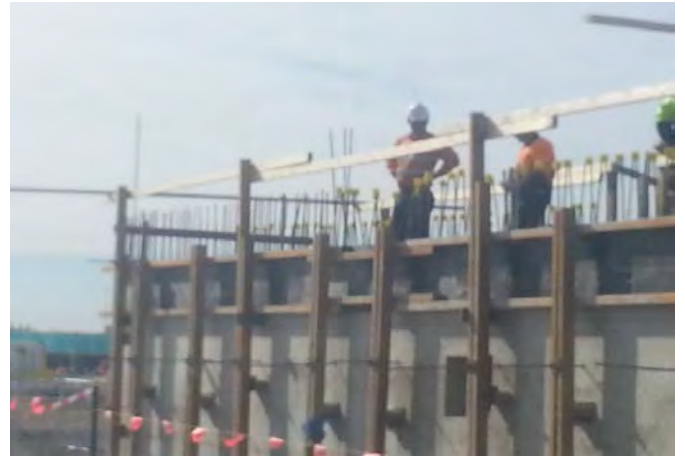
*Photo 002: Uncapped starter bars.*

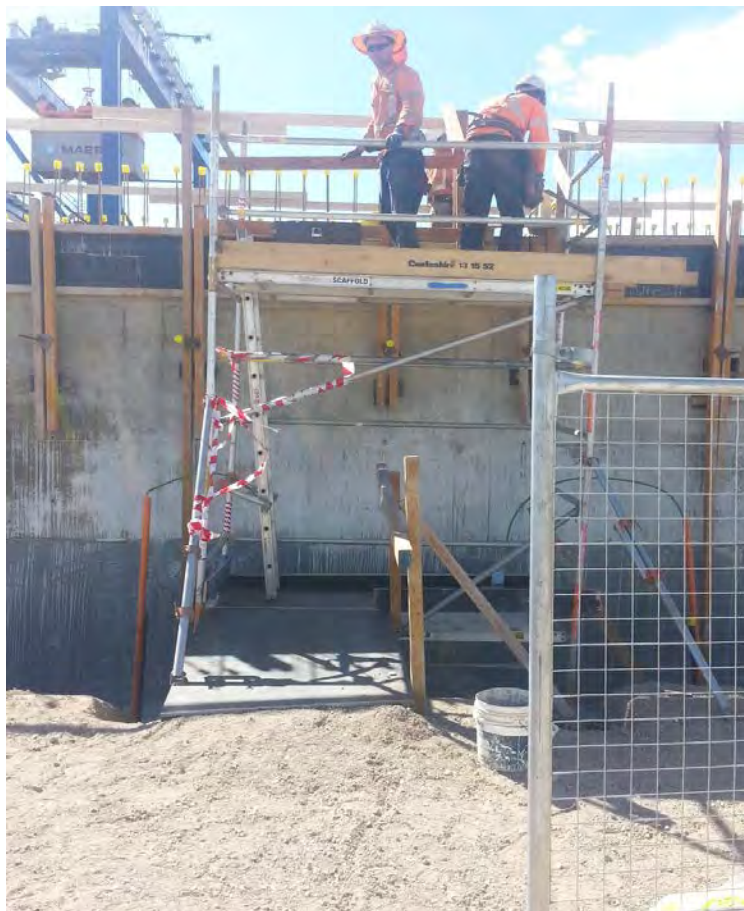
No.	Details	Score	Comment
1	Substation scaffold missing scaff tag and has structural issues. Recommend a competent person affixes a scaff tag to every access point to all scaffold erected on site. The tag should include an inspection date, full name of the competent person and their contact phone number as a minimum. Additionally the scaffold should comply with <i>AS/NZS 1576.1:2010 Scaffolding General Requirements</i> and <i>AS/NZS 4576:1995 Guidelines for Scaffolding</i> .	-1	
2	Starter caps not present on starter bars on the roof of the substation. Recommend workers remain vigilant and replace caps as often as reasonably practical.	-1	
3			
4			
5			
Total		-2

*Photo 003: Substation scaffolding with no scaff tag and not tied in to the wall.*

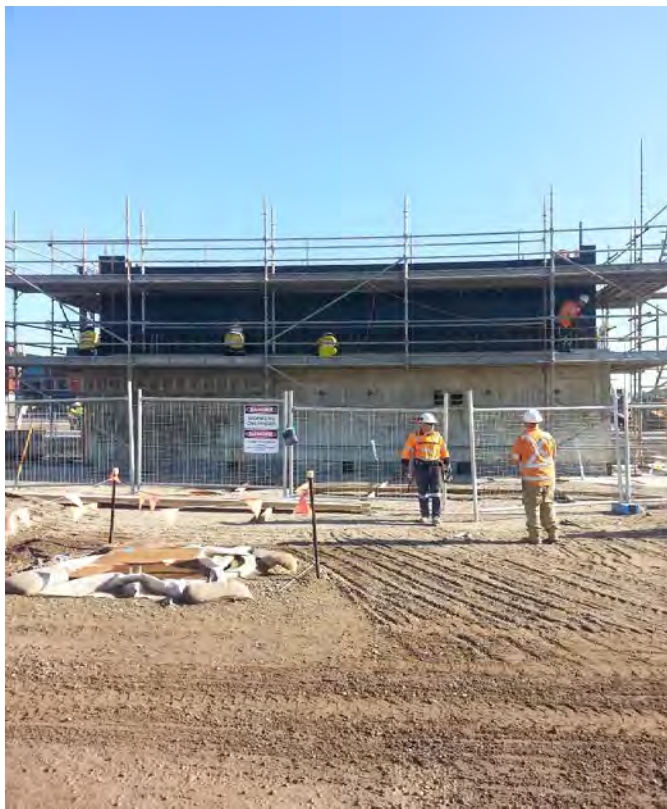
*Photo001: The new standard of scaffold used at Port Botany. KNF have subcontracted the work to a professional installation company and the quality has improved 10 fold. Note the kickboards, longitudinal bracing, access stairs, mid and guard rails. Well-done.*

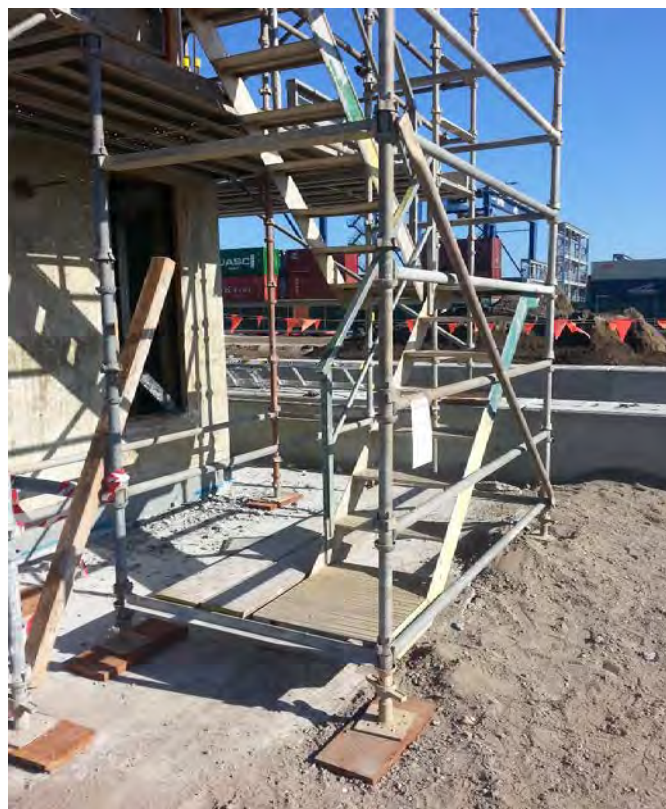
*Photo002: Safe access and egress from the scaffold now possible. Scaffold tag in place, but not ideal. Perhaps an opportunity for improvement on behalf of the subcontractor ACROW (tag appears to be missing the next 30 day inspection date).*

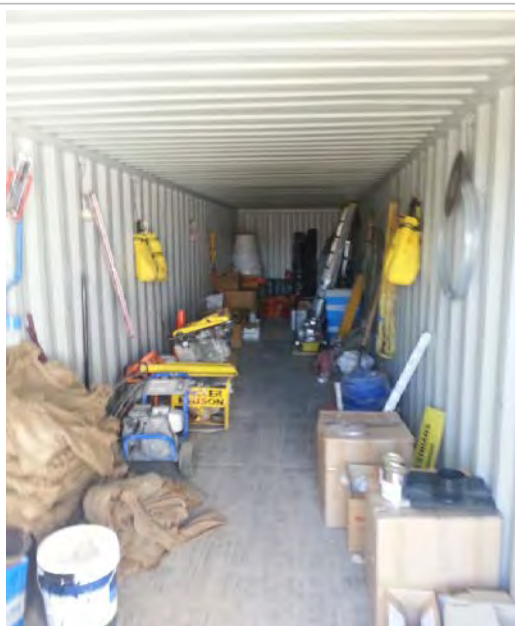
*Photo003: Burton site container in an excellent state of housekeeping.*

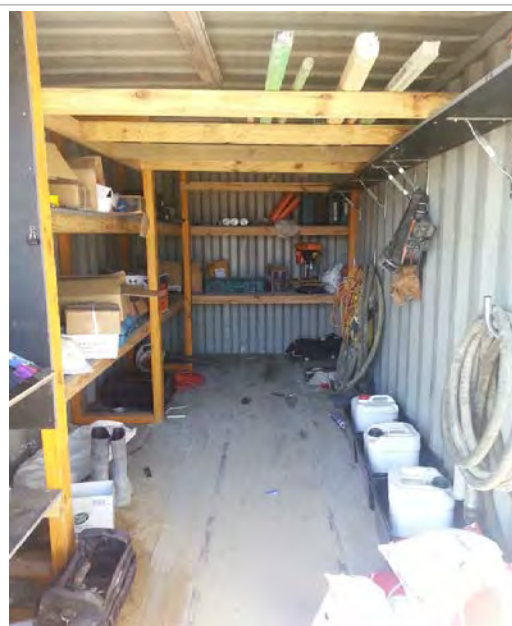
*Photo004: KNF site container in an excellent state of housekeeping. Note the use of secondary spill containment (black plastic buckets). This level of care is taken all over site at Port Botany and not seen so predominantly on any other site I inspect. Well done for setting a high standard.*
