# Annual Environmental Management Report 2014

Sydney International Container Terminal 3  
Phase 2

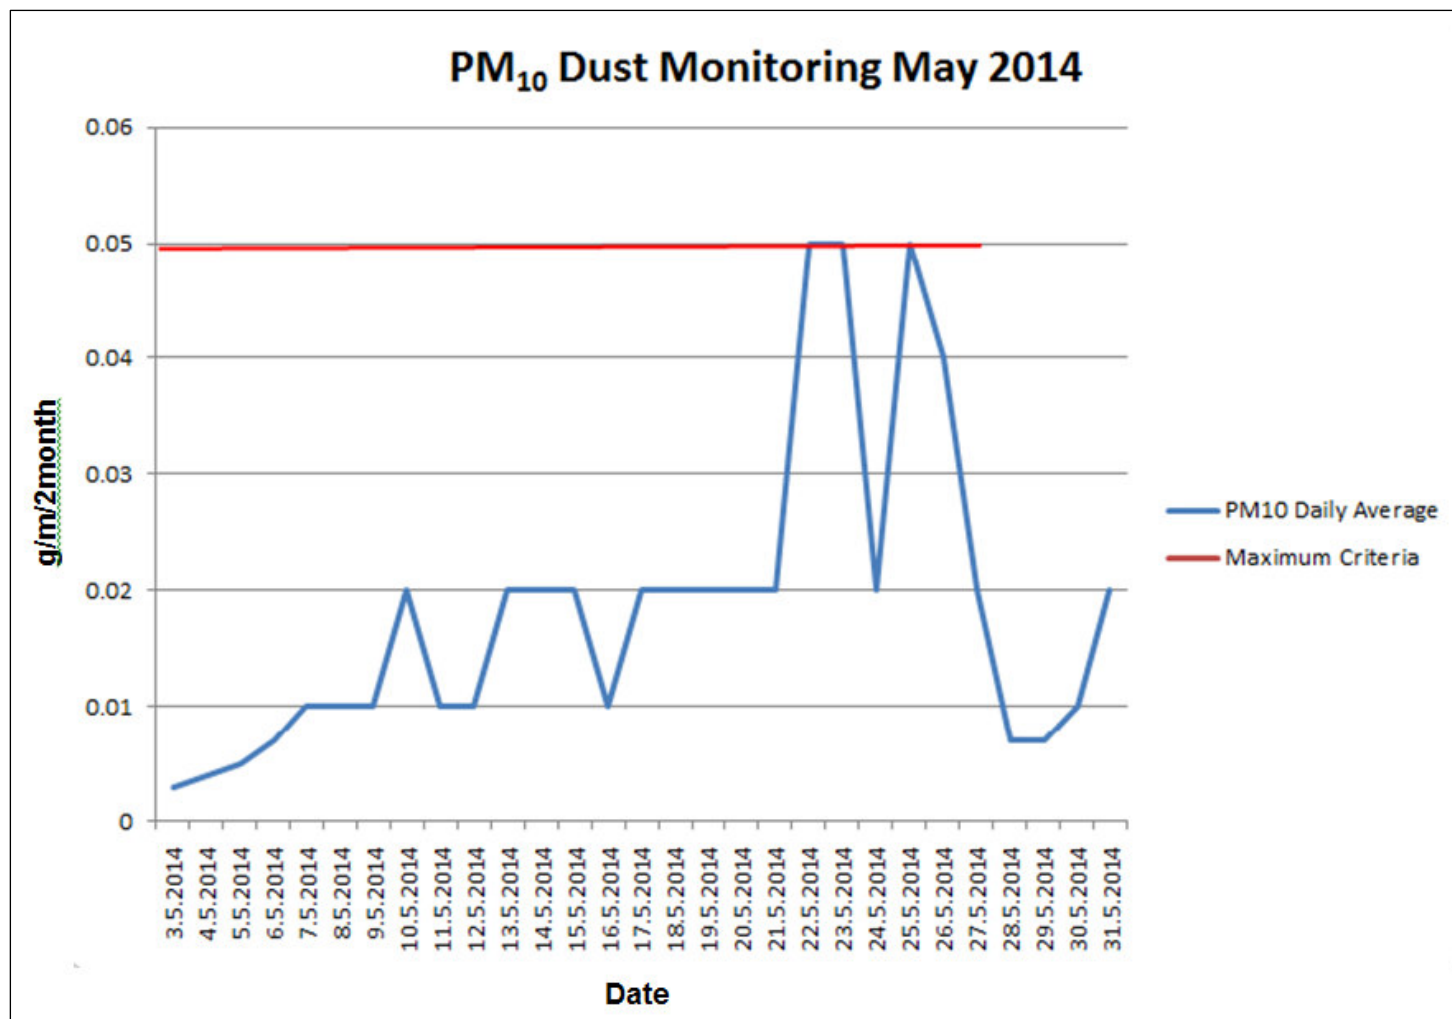
PM<sub>10</sub> daily dust averages for the month of May, all readings are under the upper limit criteria of 0.05.

Note: The monitor malfunctioned during 1-2 May, no data available for these dates.

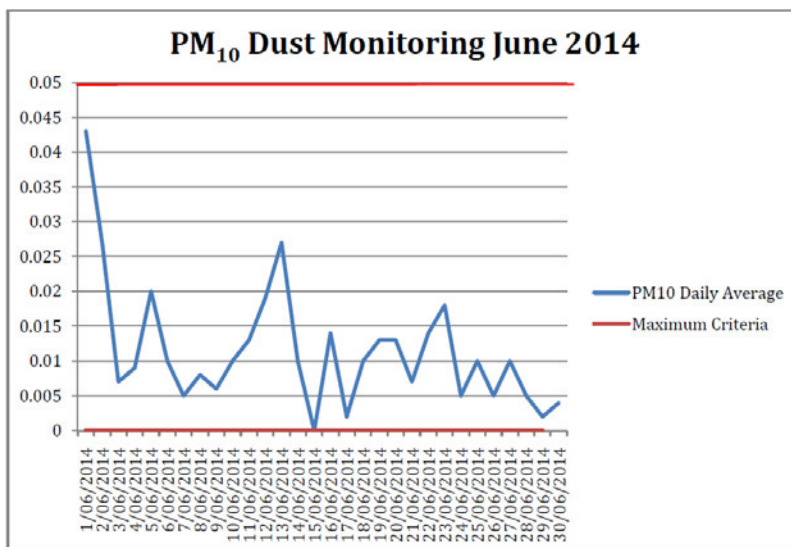
PM<sub>10</sub> daily dust averages for the month of June. All readings are under the upper limit criteria of 0.05 with the exception of two readings at 18:40 and 20:30 on June 26 (0.069, 0.353mg/L).

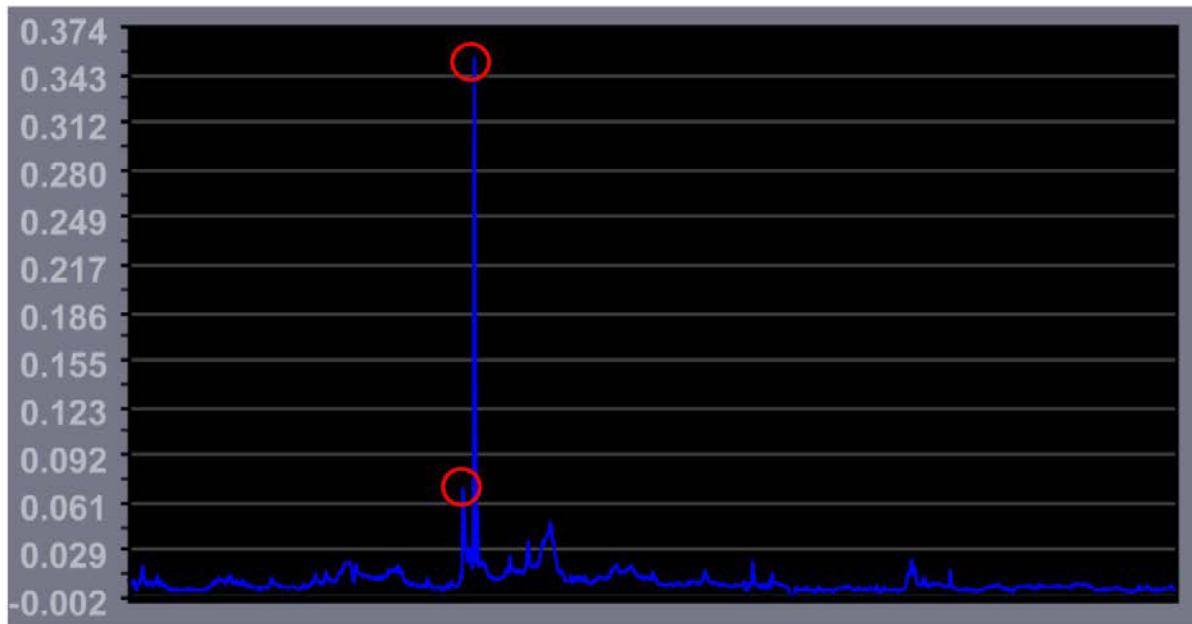
Monthly PM10 real-time monitor showing exceedences on 26 June 2014 at 18:40 and 20:30 possibly due to high winds or an outside influence.

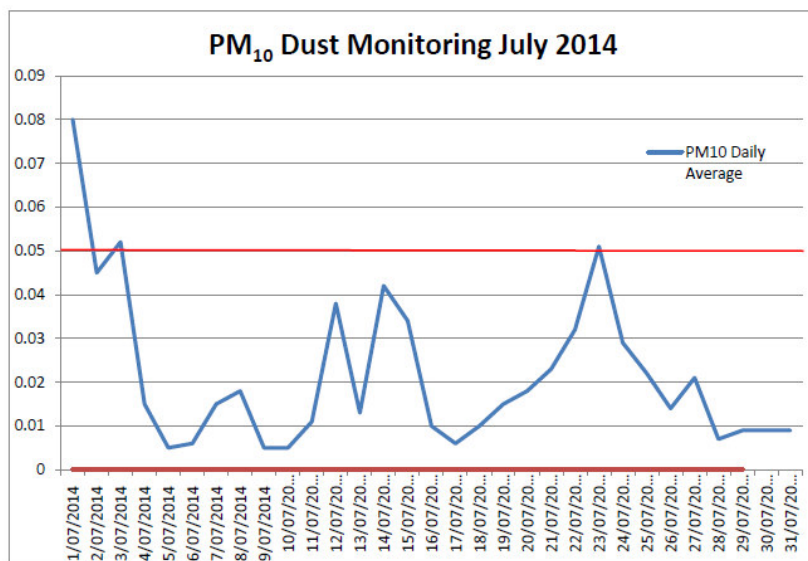
PM<sub>10</sub> daily dust averages for the month of July. Readings are generally under the upper limit criteria of 0.05 with the exception of three readings at on 1, 3 and 23 July 2014.

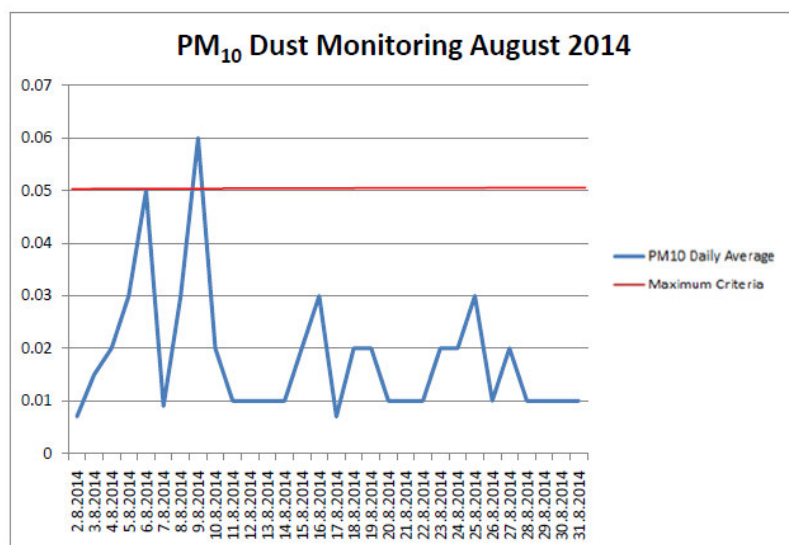
PM<sub>10</sub> daily dust averages for the month of August 2014. Readings are generally under the upper limit criteria of 0.05 with the exception of two readings on 6 and 9 July (0.05 and 0.06 respectively).

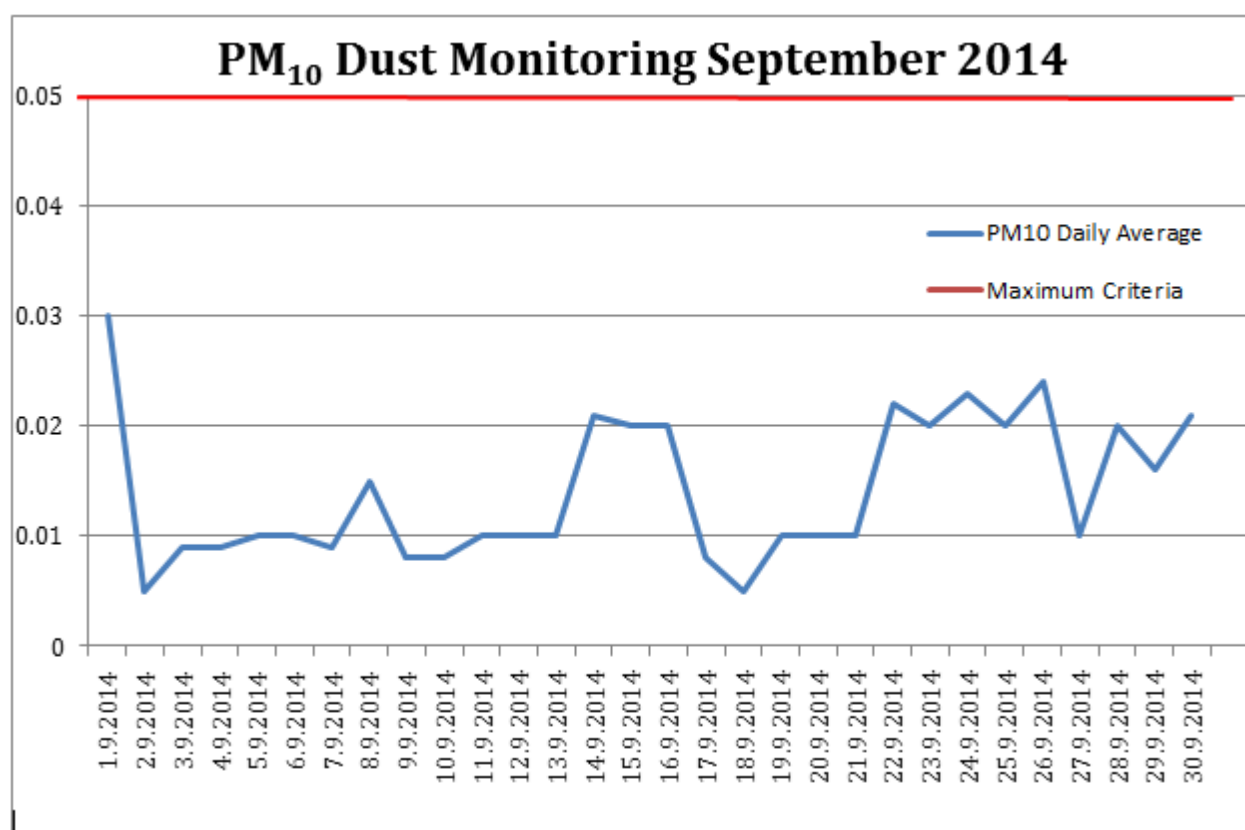
PM<sub>10</sub> daily dust averages for the month of September 2014. Readings were under the upper limit criteria of 0.05 g/m<sup>2</sup>/month.
