CLIENT MONTHLY ENVIRONMENTAL REPORT

**SICTL Container International Container
Terminal Limited**

Report Number: 05

Period: October 2014

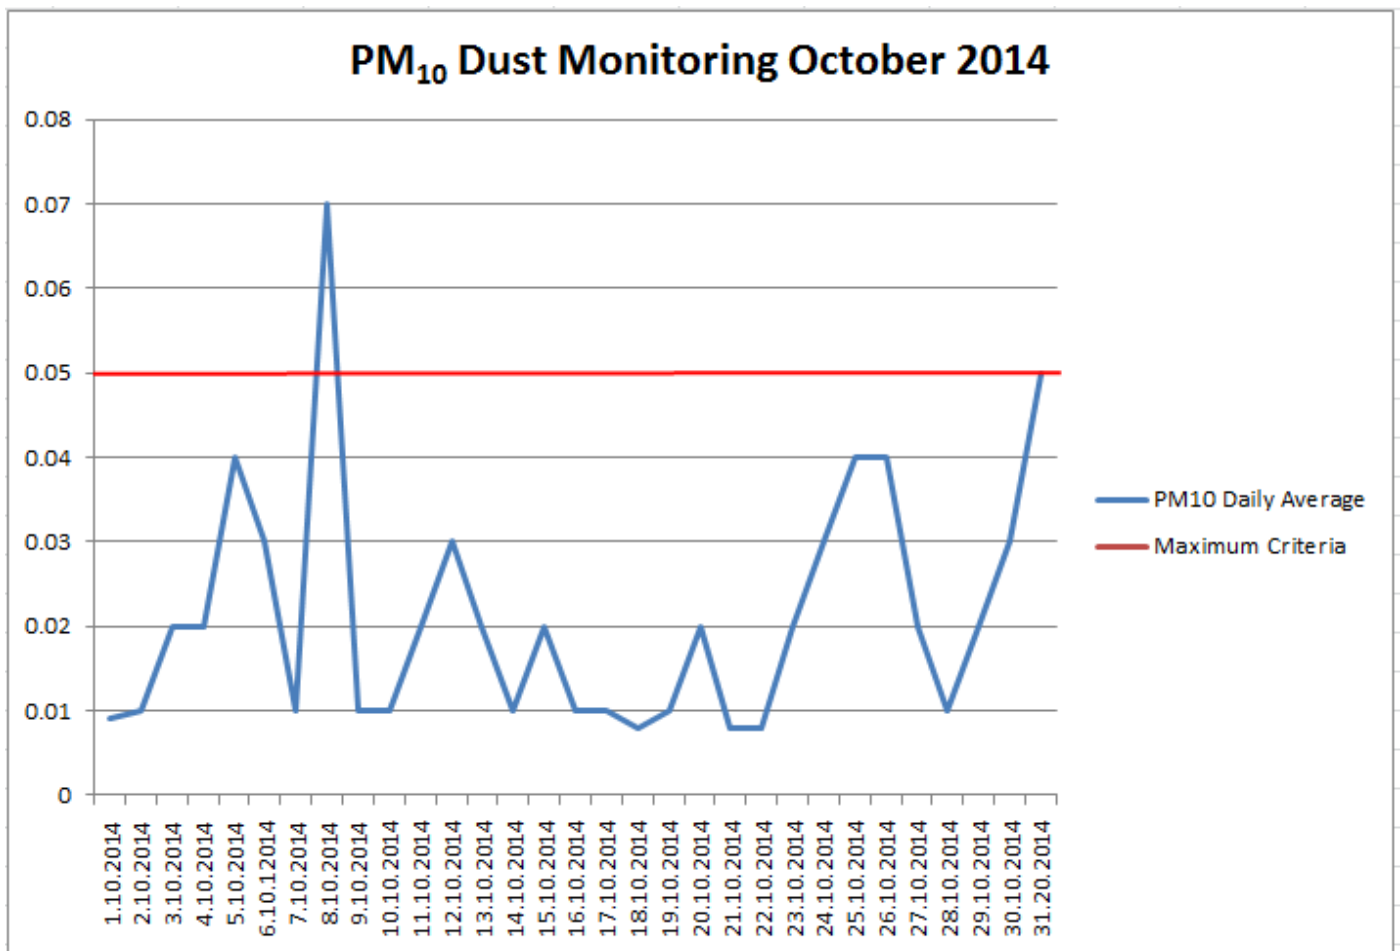
PM₁₀ daily dust averages for the month of October 2014. Readings were generally under the upper limit criteria of 0.05 g/m²/month with the exception of 7 October which has a reading of 0.07.

One exceedence of project PM₁₀ particulate matter criteria were recorded during October 2014. This exceedences was recorded on the 7 October 2014. An investigation into the exceedences identified the following information:

- A number of controls were in place on site at the time the exceedance occurred and that no dust or particulate matter was observed leaving the site, controls included but weren't limited to use of a watercart and sweeper, compaction of stockpiles, sealing up of areas and prior placement and compaction of select material along entry and exit points.

The investigations concluded that all appropriate and reasonable mitigation measures had been undertaken at the site and that construction works did not represent the source of the exceedance.

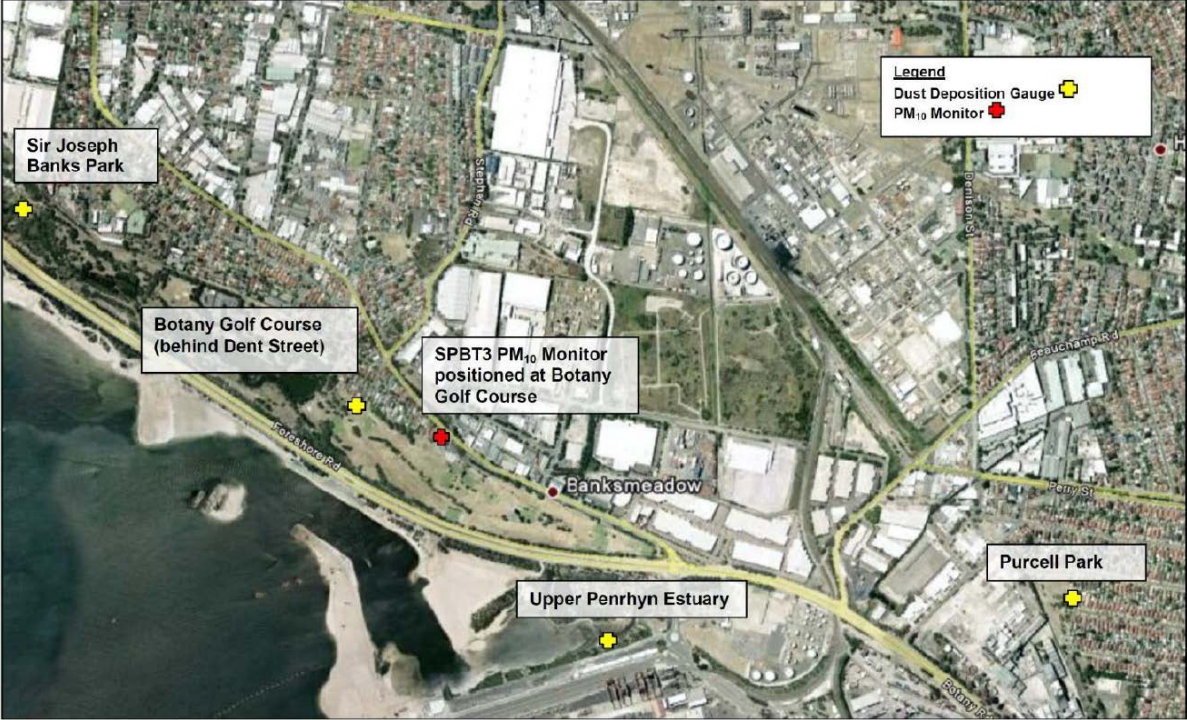
Dust Monitoring Locations

Four dust deposition gauges are installed in the areas surrounding the Port Botany redevelopment. All results received for the deposition gauges were within EPA guidelines and Project criteria for the month of October. No residential properties or road networks have been impacted by dust emanating from the Port expansion construction works and there have been no dust complaints received by the project during this monitoring period.
