CLIENT MONTHLY ENVIRONMENTAL REPORT

**SICTL Container International Container
Terminal Limited**

Contract Number: 350
Report Number: 06
Period: November 2014

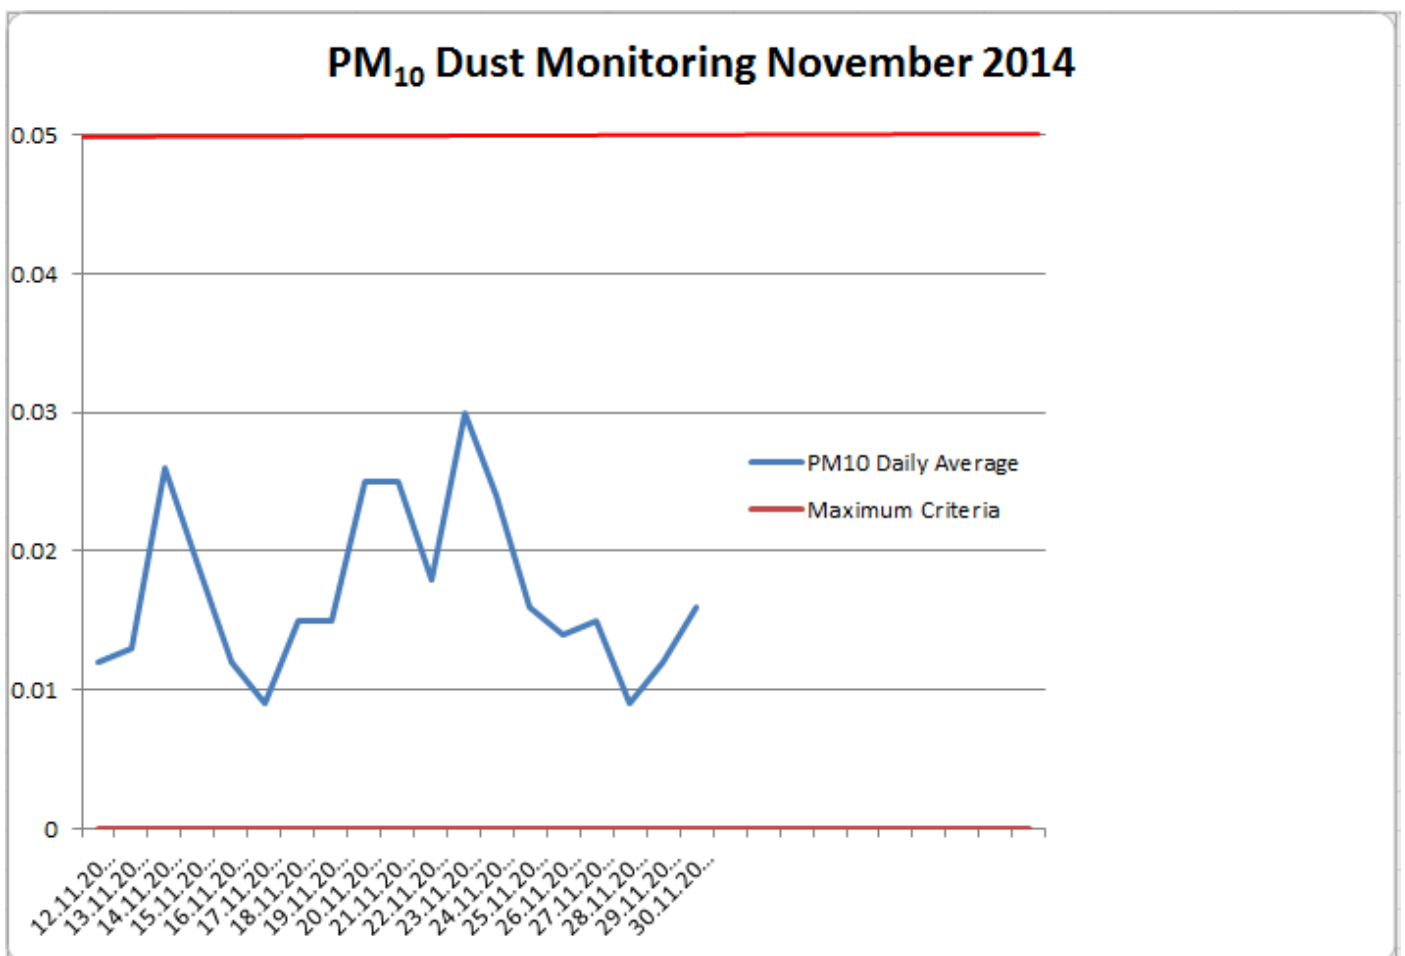
PM₁₀ daily dust averages for the month of November 2014. Readings were under the upper limit criteria of 0.05 g/m²/month.
