# CLIENT MONTHLY ENVIRONMENTAL REPORT

**SICTL Container International Container  
Terminal Limited**

**Report Number:** 02

**Period:** August 2014

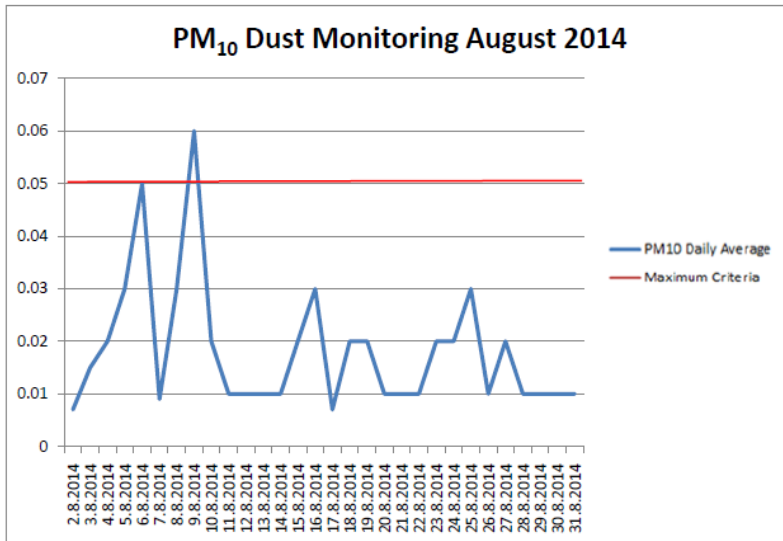
PM<sub>10</sub> daily dust averages for the month of August 2014. Readings are generally under the upper limit criteria of 0.05 with the exception of two readings on 6 and 9 July (0.05 and 0.06 respectively).
