# CLIENT MONTHLY ENVIRONMENTAL REPORT

**SICTL Container International Container  
Terminal Limited**

**Report Number:** 03

**Period:** September 2014

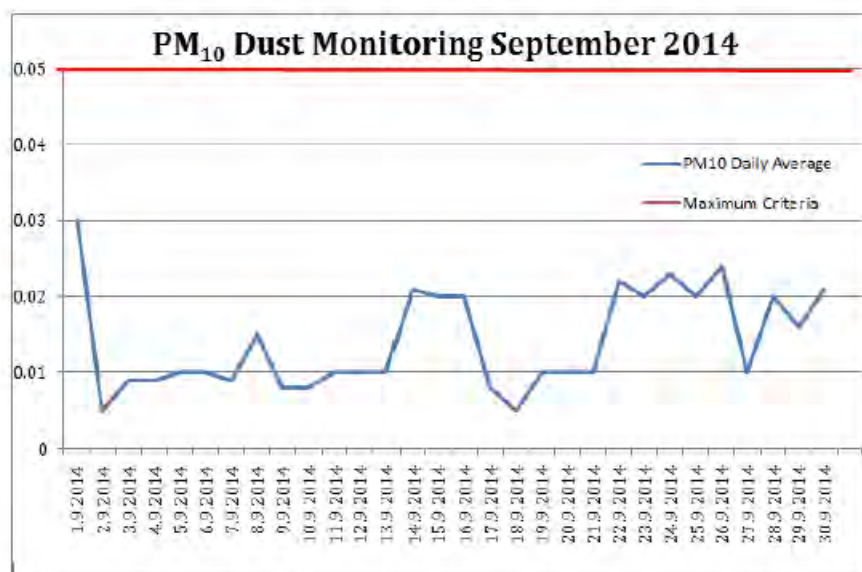
PM<sub>10</sub> daily dust averages for the month of September 2014. Readings were under the upper limit criteria of 0.05 g/m<sup>2</sup>/month.
